DOT/FAA/RD-91/1

**Composite Profiles of  
Helicopter Mishaps at  
Heliports and Airports**

January 1992

Final Report

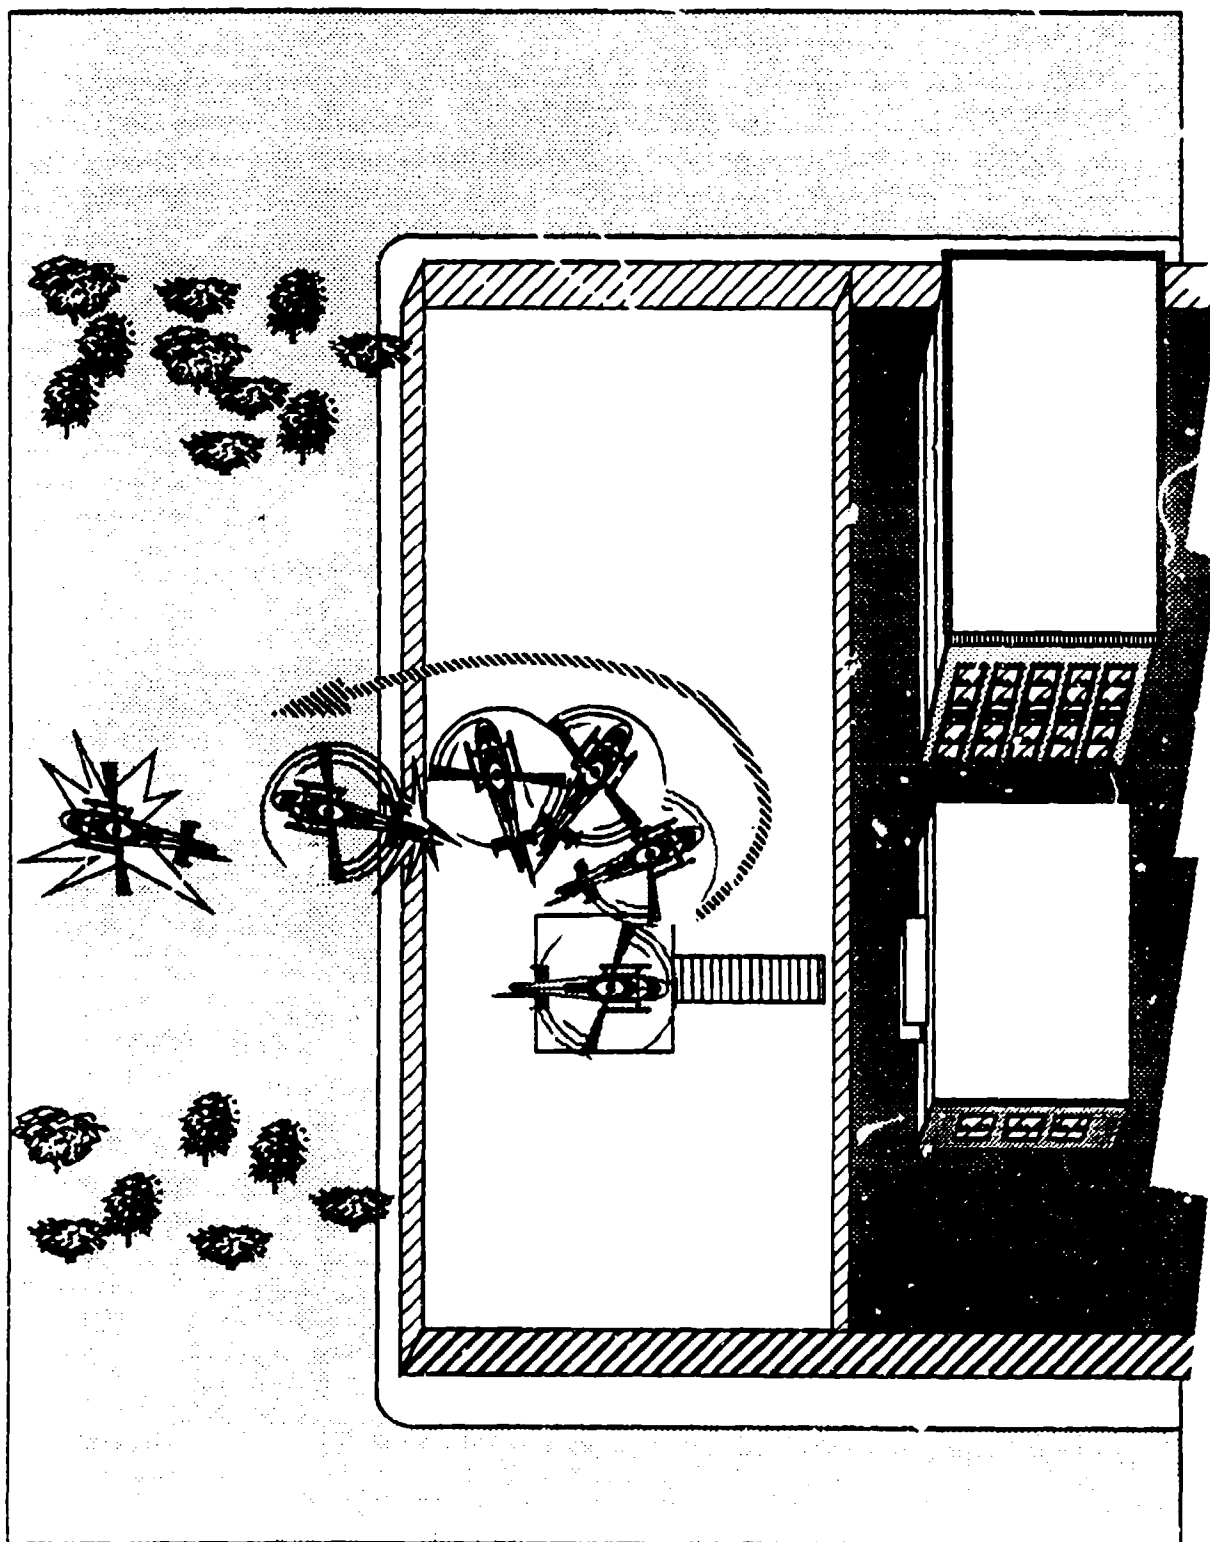
FIGURE 22 ENGINE FAILURE ON TAKEOFF

Approach/Departure Path - At first glance, the takeoff flight path chosen by the pilot and depicted in figure 22 seems unreasonable. Even though a departure path perpendicular to that flown would have given the pilot more room, mishap data shows that pilots do not always choose the most appropriate approach/departure path. The obvious lesson here is that pilots should give themselves as much leeway as possible in all situations. A good rule of thumb to remember is that "short cuts generally short cut safety."

Rejected Takeoff Groundspace - Mechanical failures do sometimes occur on takeoff. Even though this event is rare, having clear groundspace below the departure path will help to minimize the effects of such a mishap. Historic mishap data shows that safety measures, lighting, environmental (noise reduction) measures, etc. taken to protect the operator and the

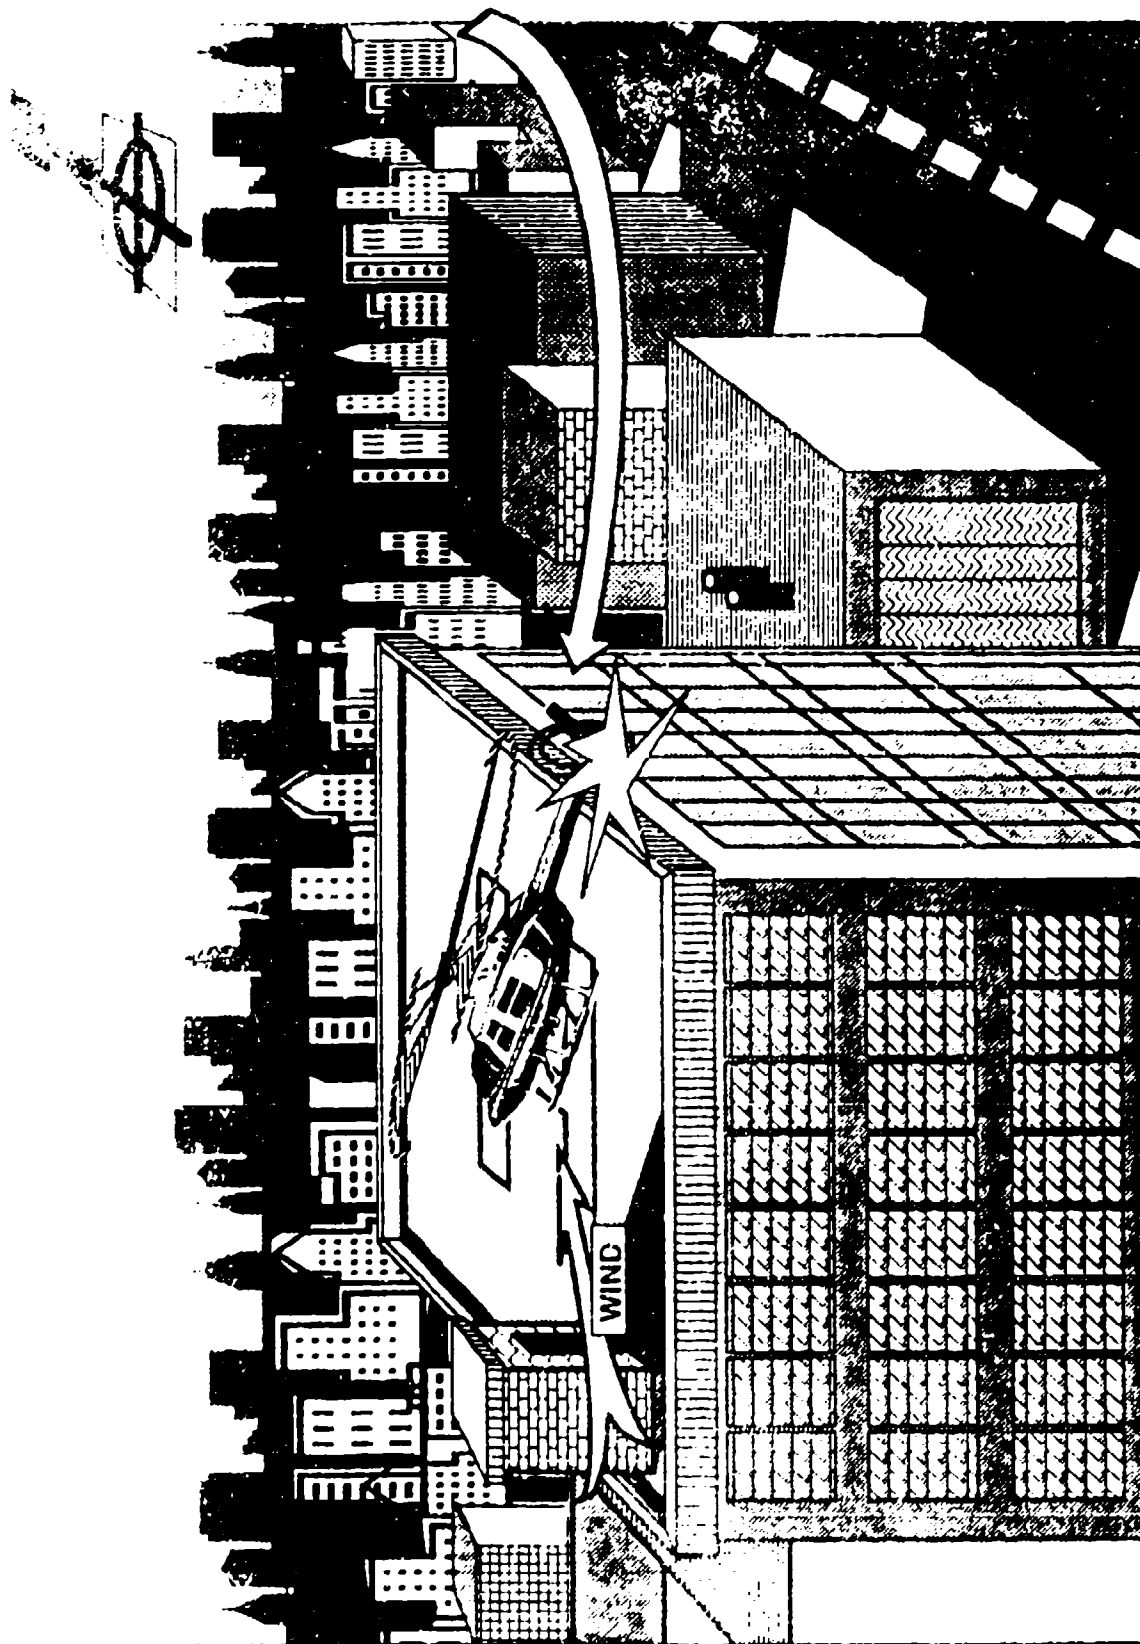
FIGURE 26 OBSTACLE STRIKE - PARAPET

In this mishap, the pilot did not have a VASI-type guidance system to assist him in executing an approach at the proper angle. Visual guidance

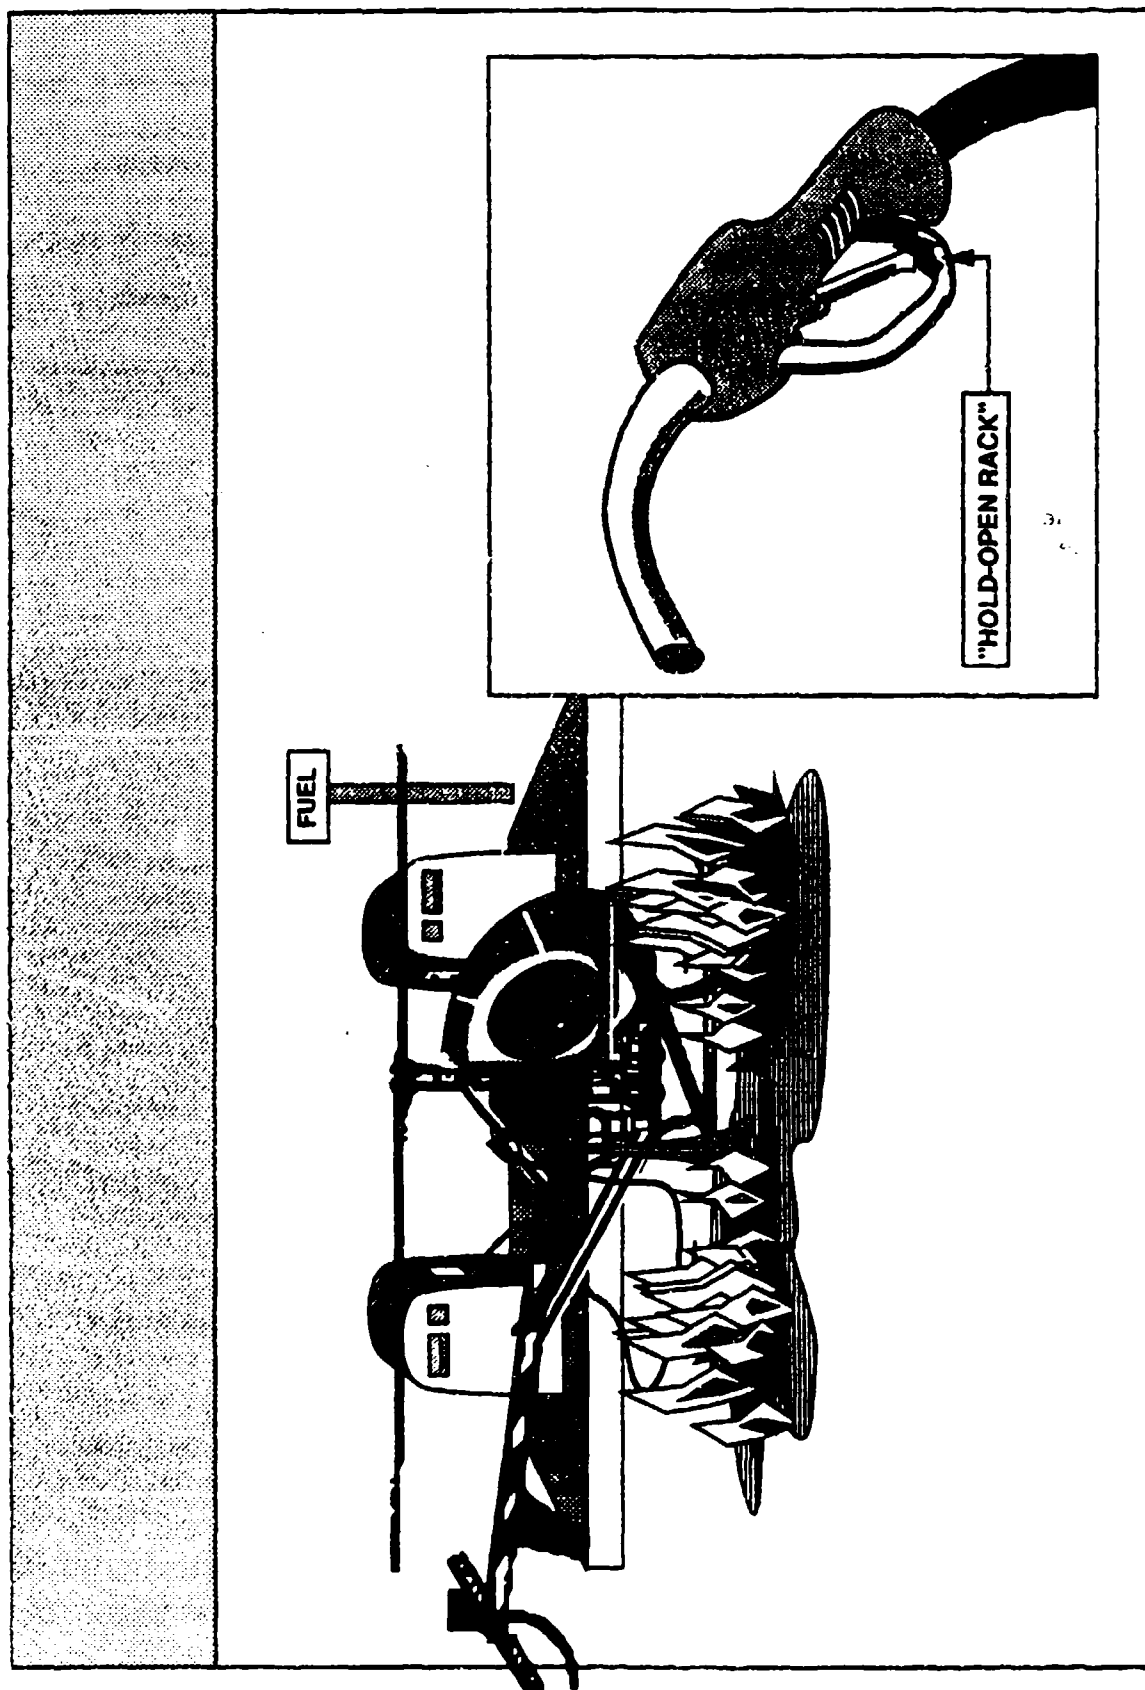
FIGURE 28 REFUELING FIRE

Fuel Nozzle - The pilot engaged the hold-open rack feature during refueling. Advisory Circular No. 00-34A (reference 10) addresses the subject of "Aircraft Ground Handling and Servicing." It states that fuel nozzle lever stop notches (hold-open racks) should be removed to avoid the possibility of an inadvertent blocking-open of the valve. The advisory circular further states "...never block the nozzle lever in the open position." Even if these nozzles have automatic fuel shut-off features there is no guarantee that it would preclude a fuel spill. The advisory circular states that: "Fuel-dispensing vehicles and stationary facilities should be equipped with appropriate fire extinguishers, fire blankets, static grounding cables, explosive proof flashlights, and ladders. Fire

Pilot Procedures - Pilots should set all switches to the "off" position following engine shutdown. Also, whenever possible, pilots should watch over refueling procedures to contribute to safety in refueling operations.
